Manhole Inspection Summary

Manhole # S31E__001MH

Inspection ☐ Is Incomplete Rating: **3) Fair**

Location Address: **118 n greene st**

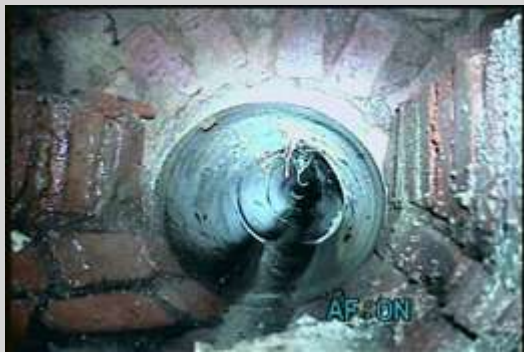
12 O'Clock Outflow

8 in. Circular Gravity Sewer
Pipe Out @ 12 O'Clock

Pipe Material: **Clay** ☐ Pipe Lined

Invert Depth: **12.33** (ft.) Flow Characteristics: **None**

Deposits: ☒ None ☐ Mud ☐ Sludge ☐ Debris ☐ Grease

Infiltration: **None** Pipe Seal Cond: **Unknown**

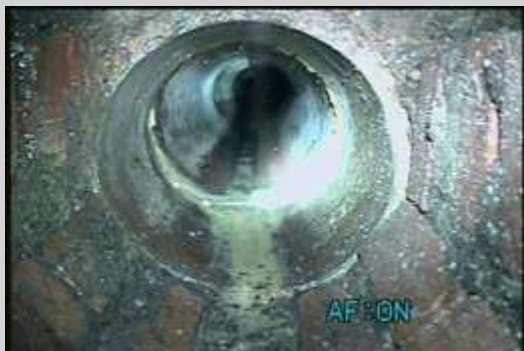
6 O'Clock Inflow

8 in. Circular Gravity Sewer
Pipe In @ 6 O'Clock

Pipe Material: **Clay** ☐ Pipe Lined

Invert Depth: **12.16** (ft.) Flow Characteristics: **None**

Deposits: ☒ None ☐ Mud ☐ Sludge ☐ Debris ☐ Grease

Infiltration: **None** Pipe Seal Cond: **Unknown**

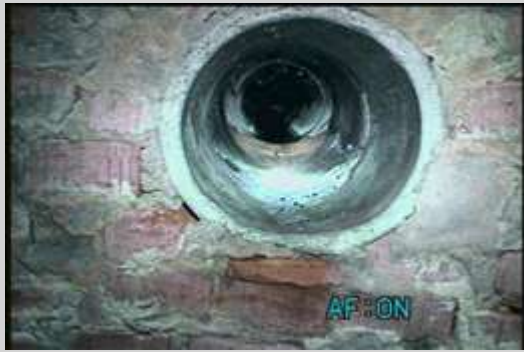
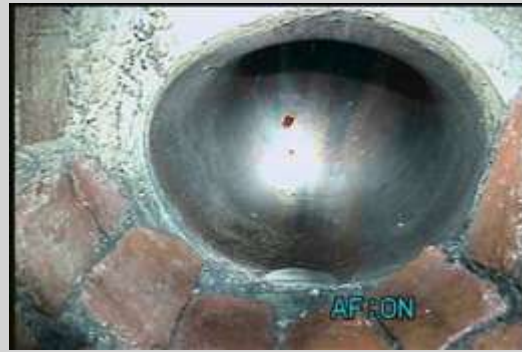
9 O'Clock Inflow

8 in. Circular Gravity Sewer

Pipe In @ 9 O'Clock

Drop In @ 9 O'Clock

Pipe Material: Clay ☐ Pipe Lined

Infiltration: None

Drop Condition: Open
